# CASE STUDY: Understanding The Cause Of Seepage - Terminal Dam

## GEOPHYSICAL INVESTIGATION TO IDENTIFY, MAP AND MODEL PREFERENTIAL SEEPAGE AROUND A DAM

Willowstick LLC - W.W. Wheeler & Associates, Inc.

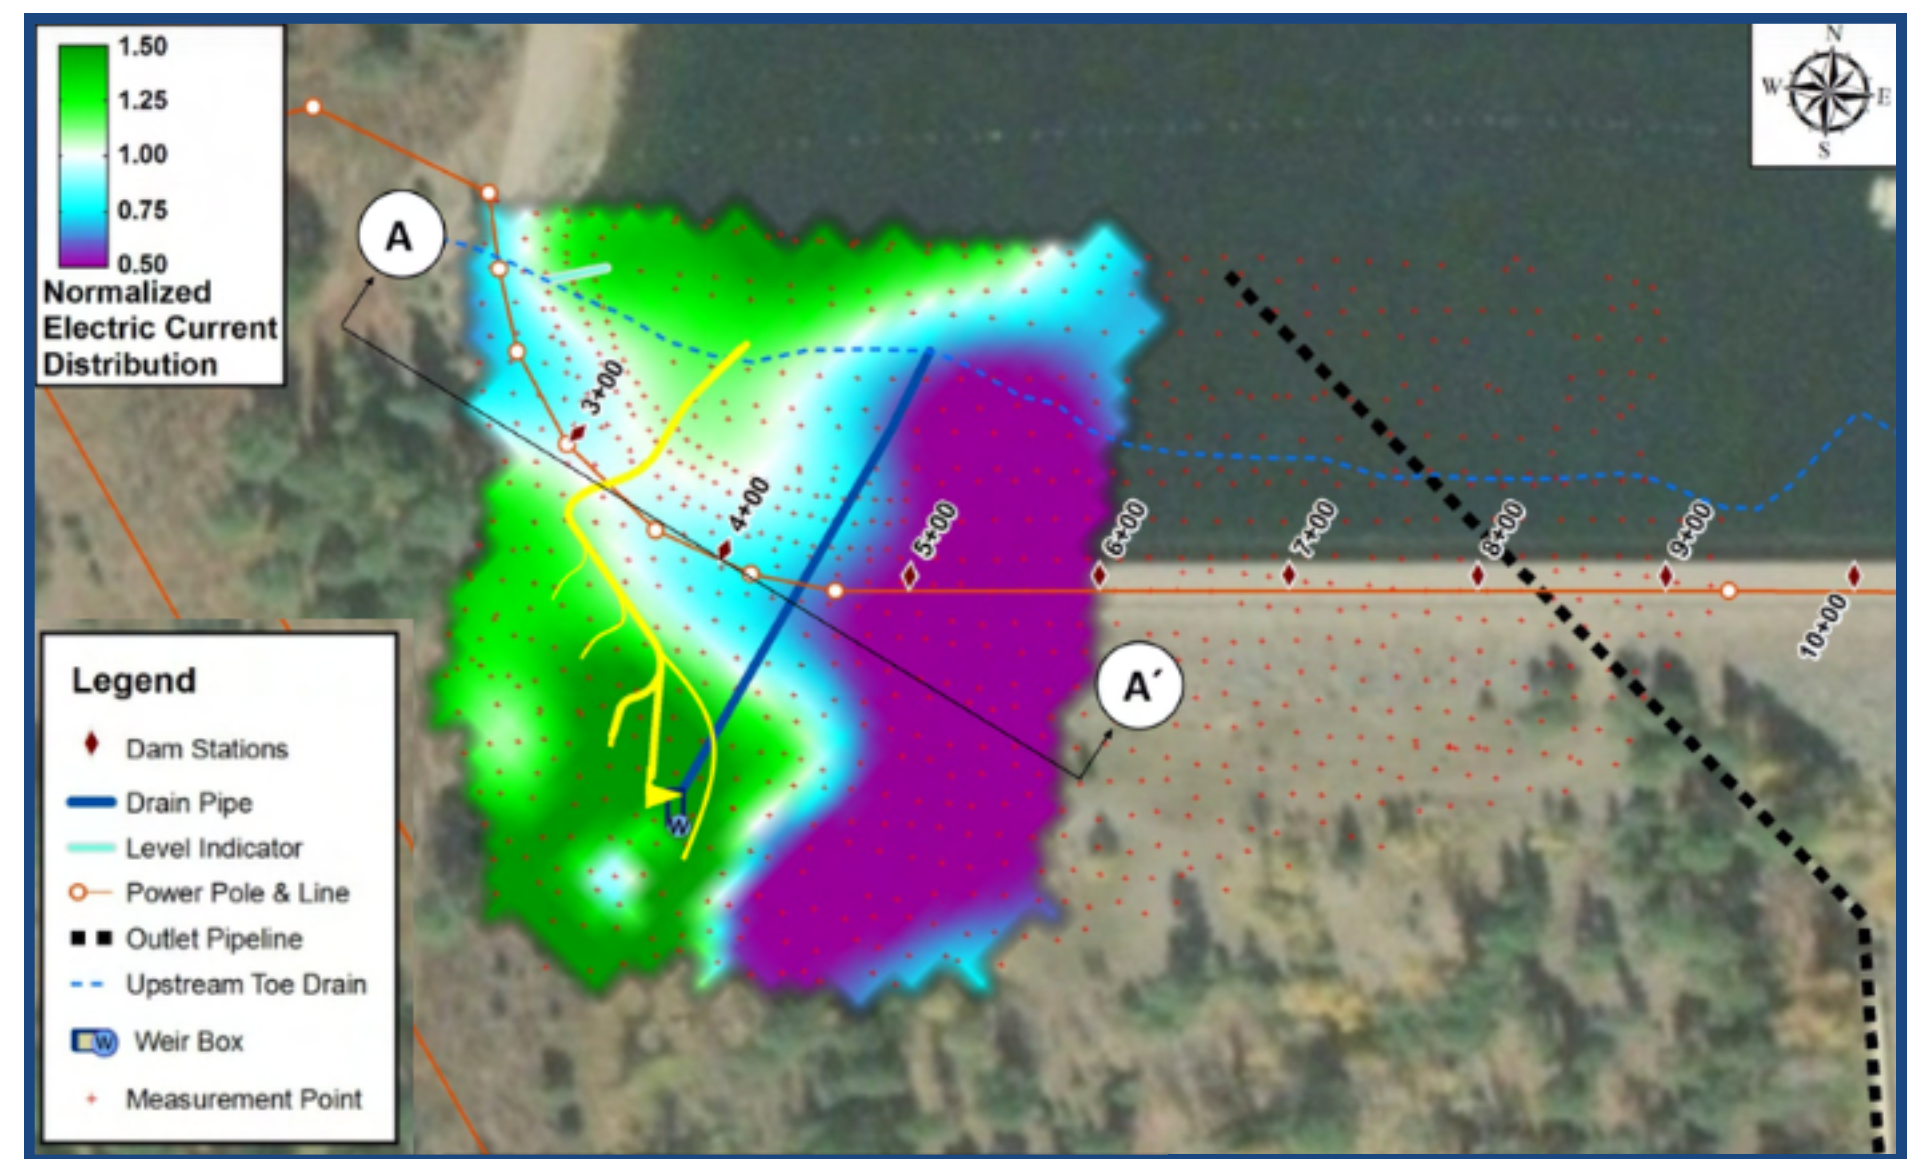
ECD Model Slice at 8330 ft.

The flow path manifested itself strongly both upstream and downstream of the crest, but it manifested only subtly beneath the crest—for two reasons. First, many of the crest measurements were impacted by the power line along the crest. The data required some filtering which helped the overall processing, but it still resulted in a zone along the crestline where it is more difficult to see at a glance, due to some interference. Secondly, the signal from the deepest part of the flow path (beneath the crest) is naturally weaker than the signal from the electric current at the upstream and downstream locations, both because it is deeper and because the overlying surface measurements are at the same time higher in elevation (top of crest).

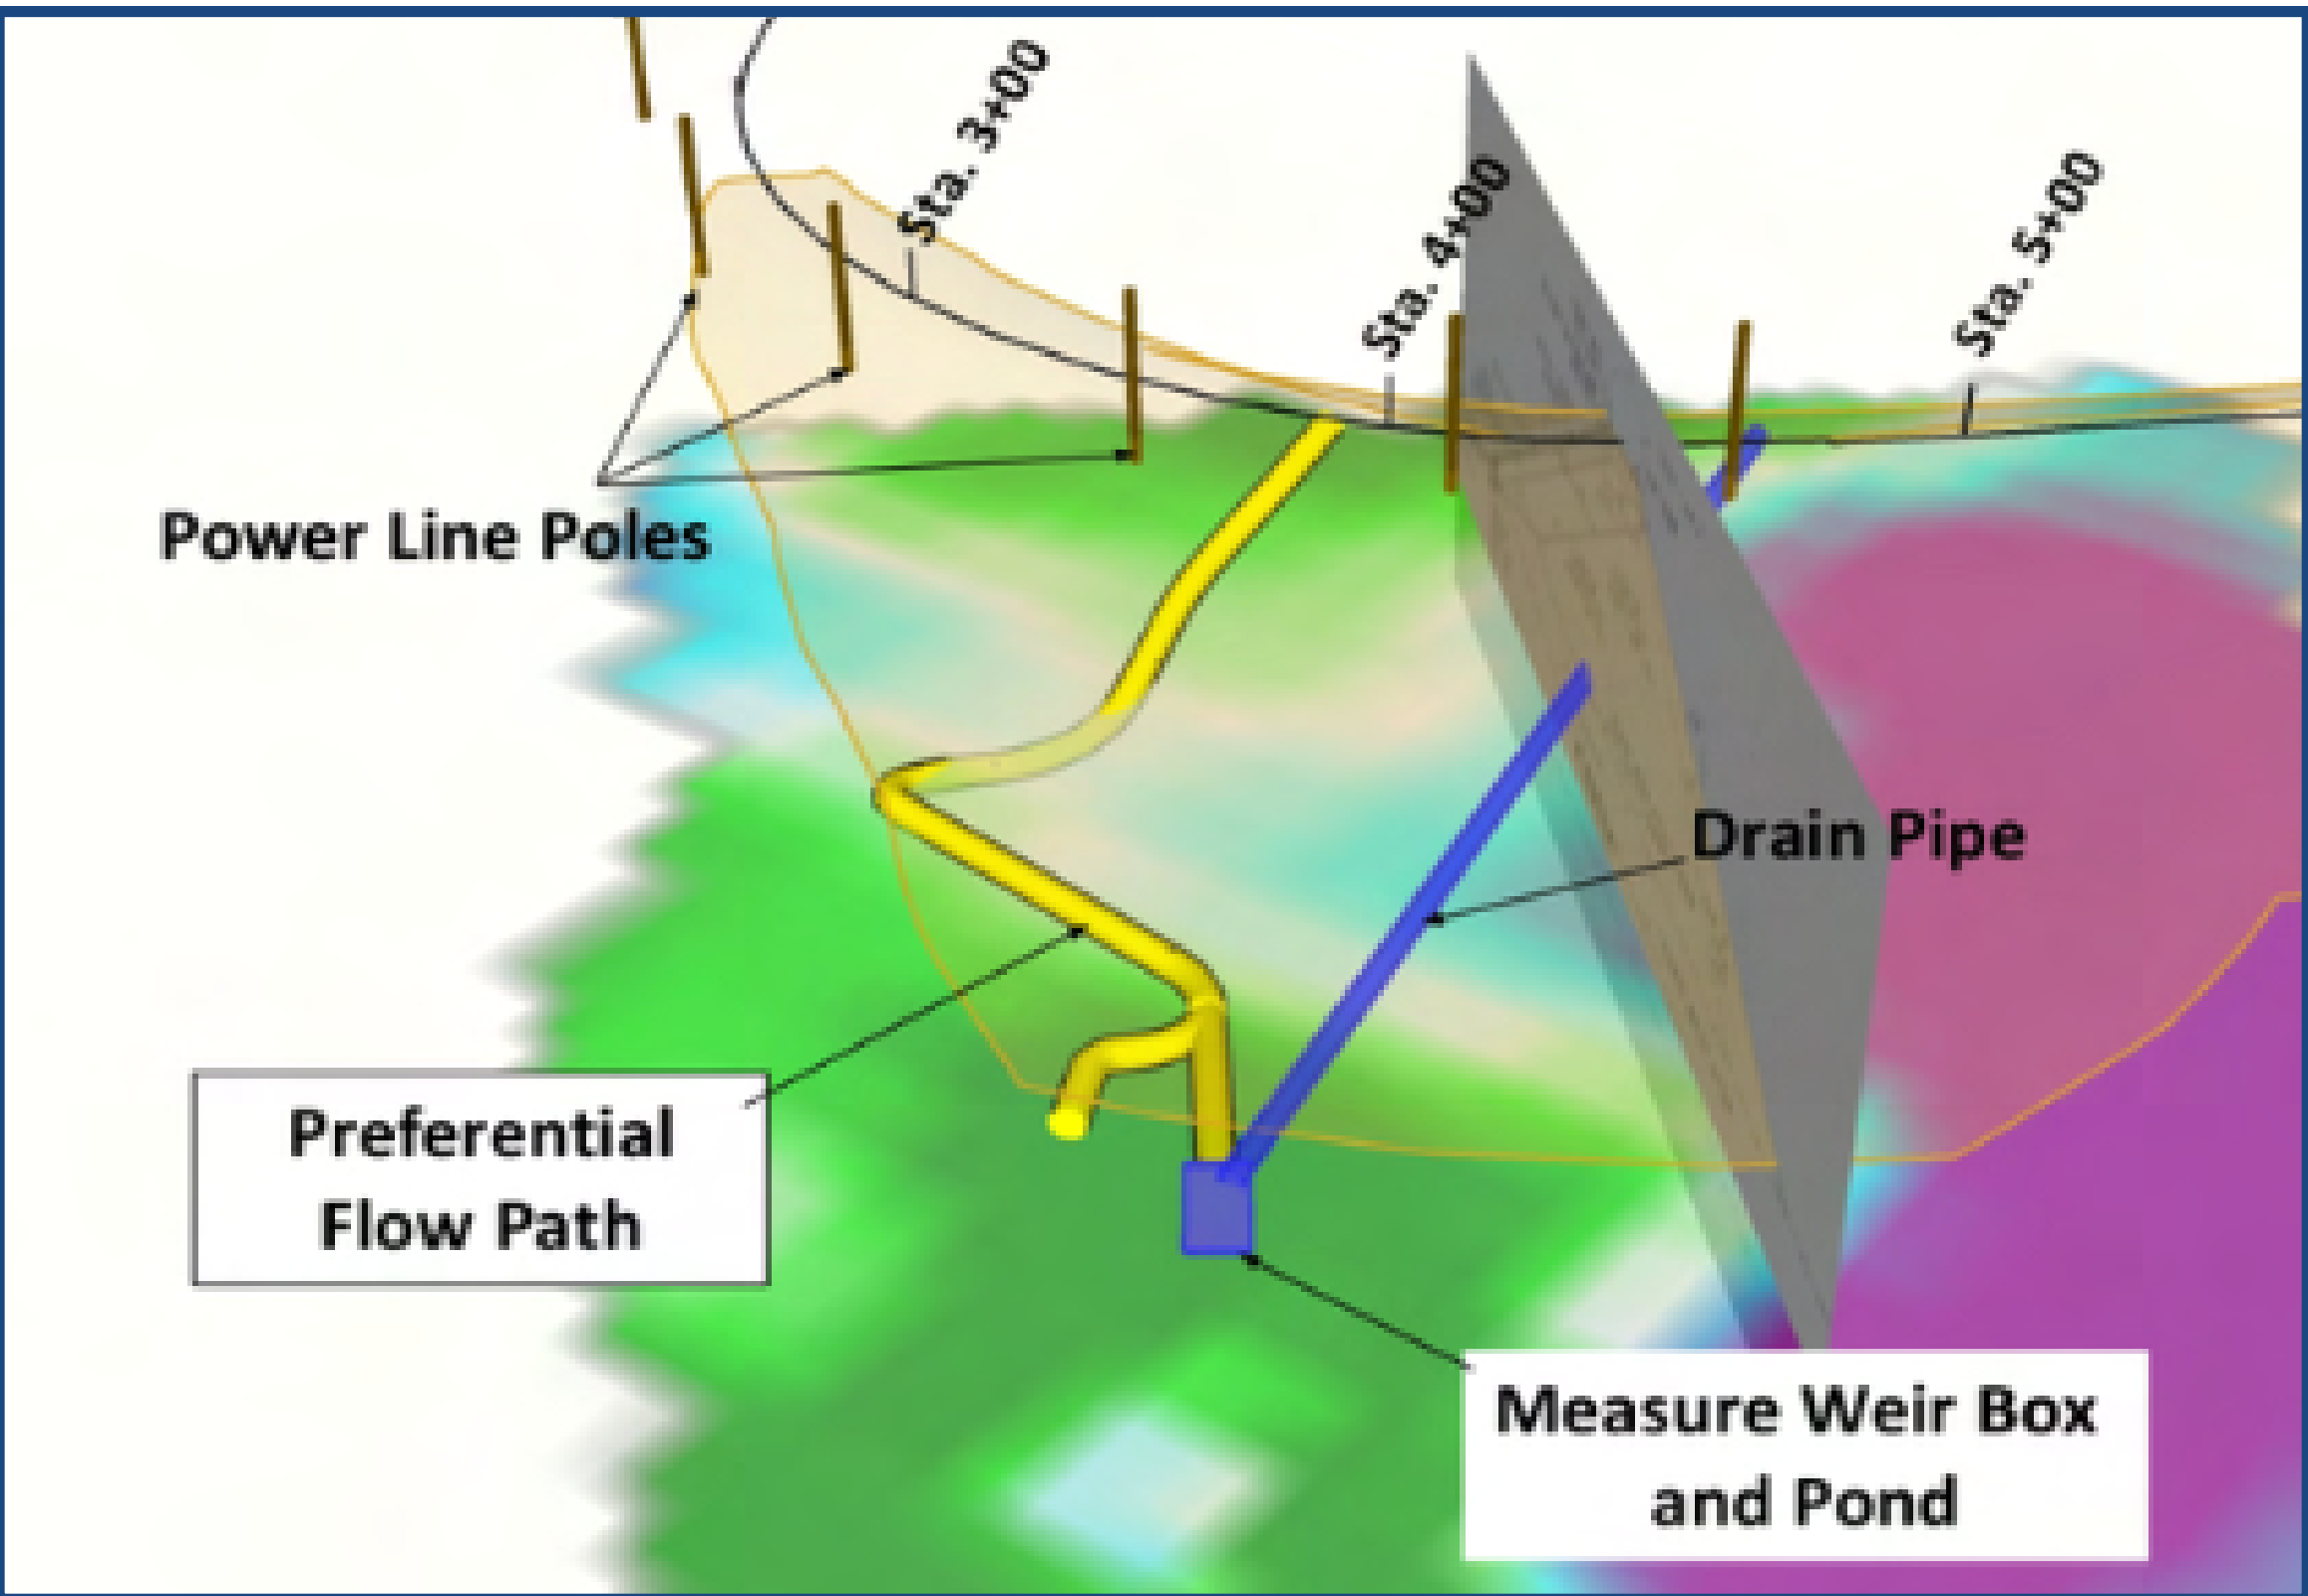
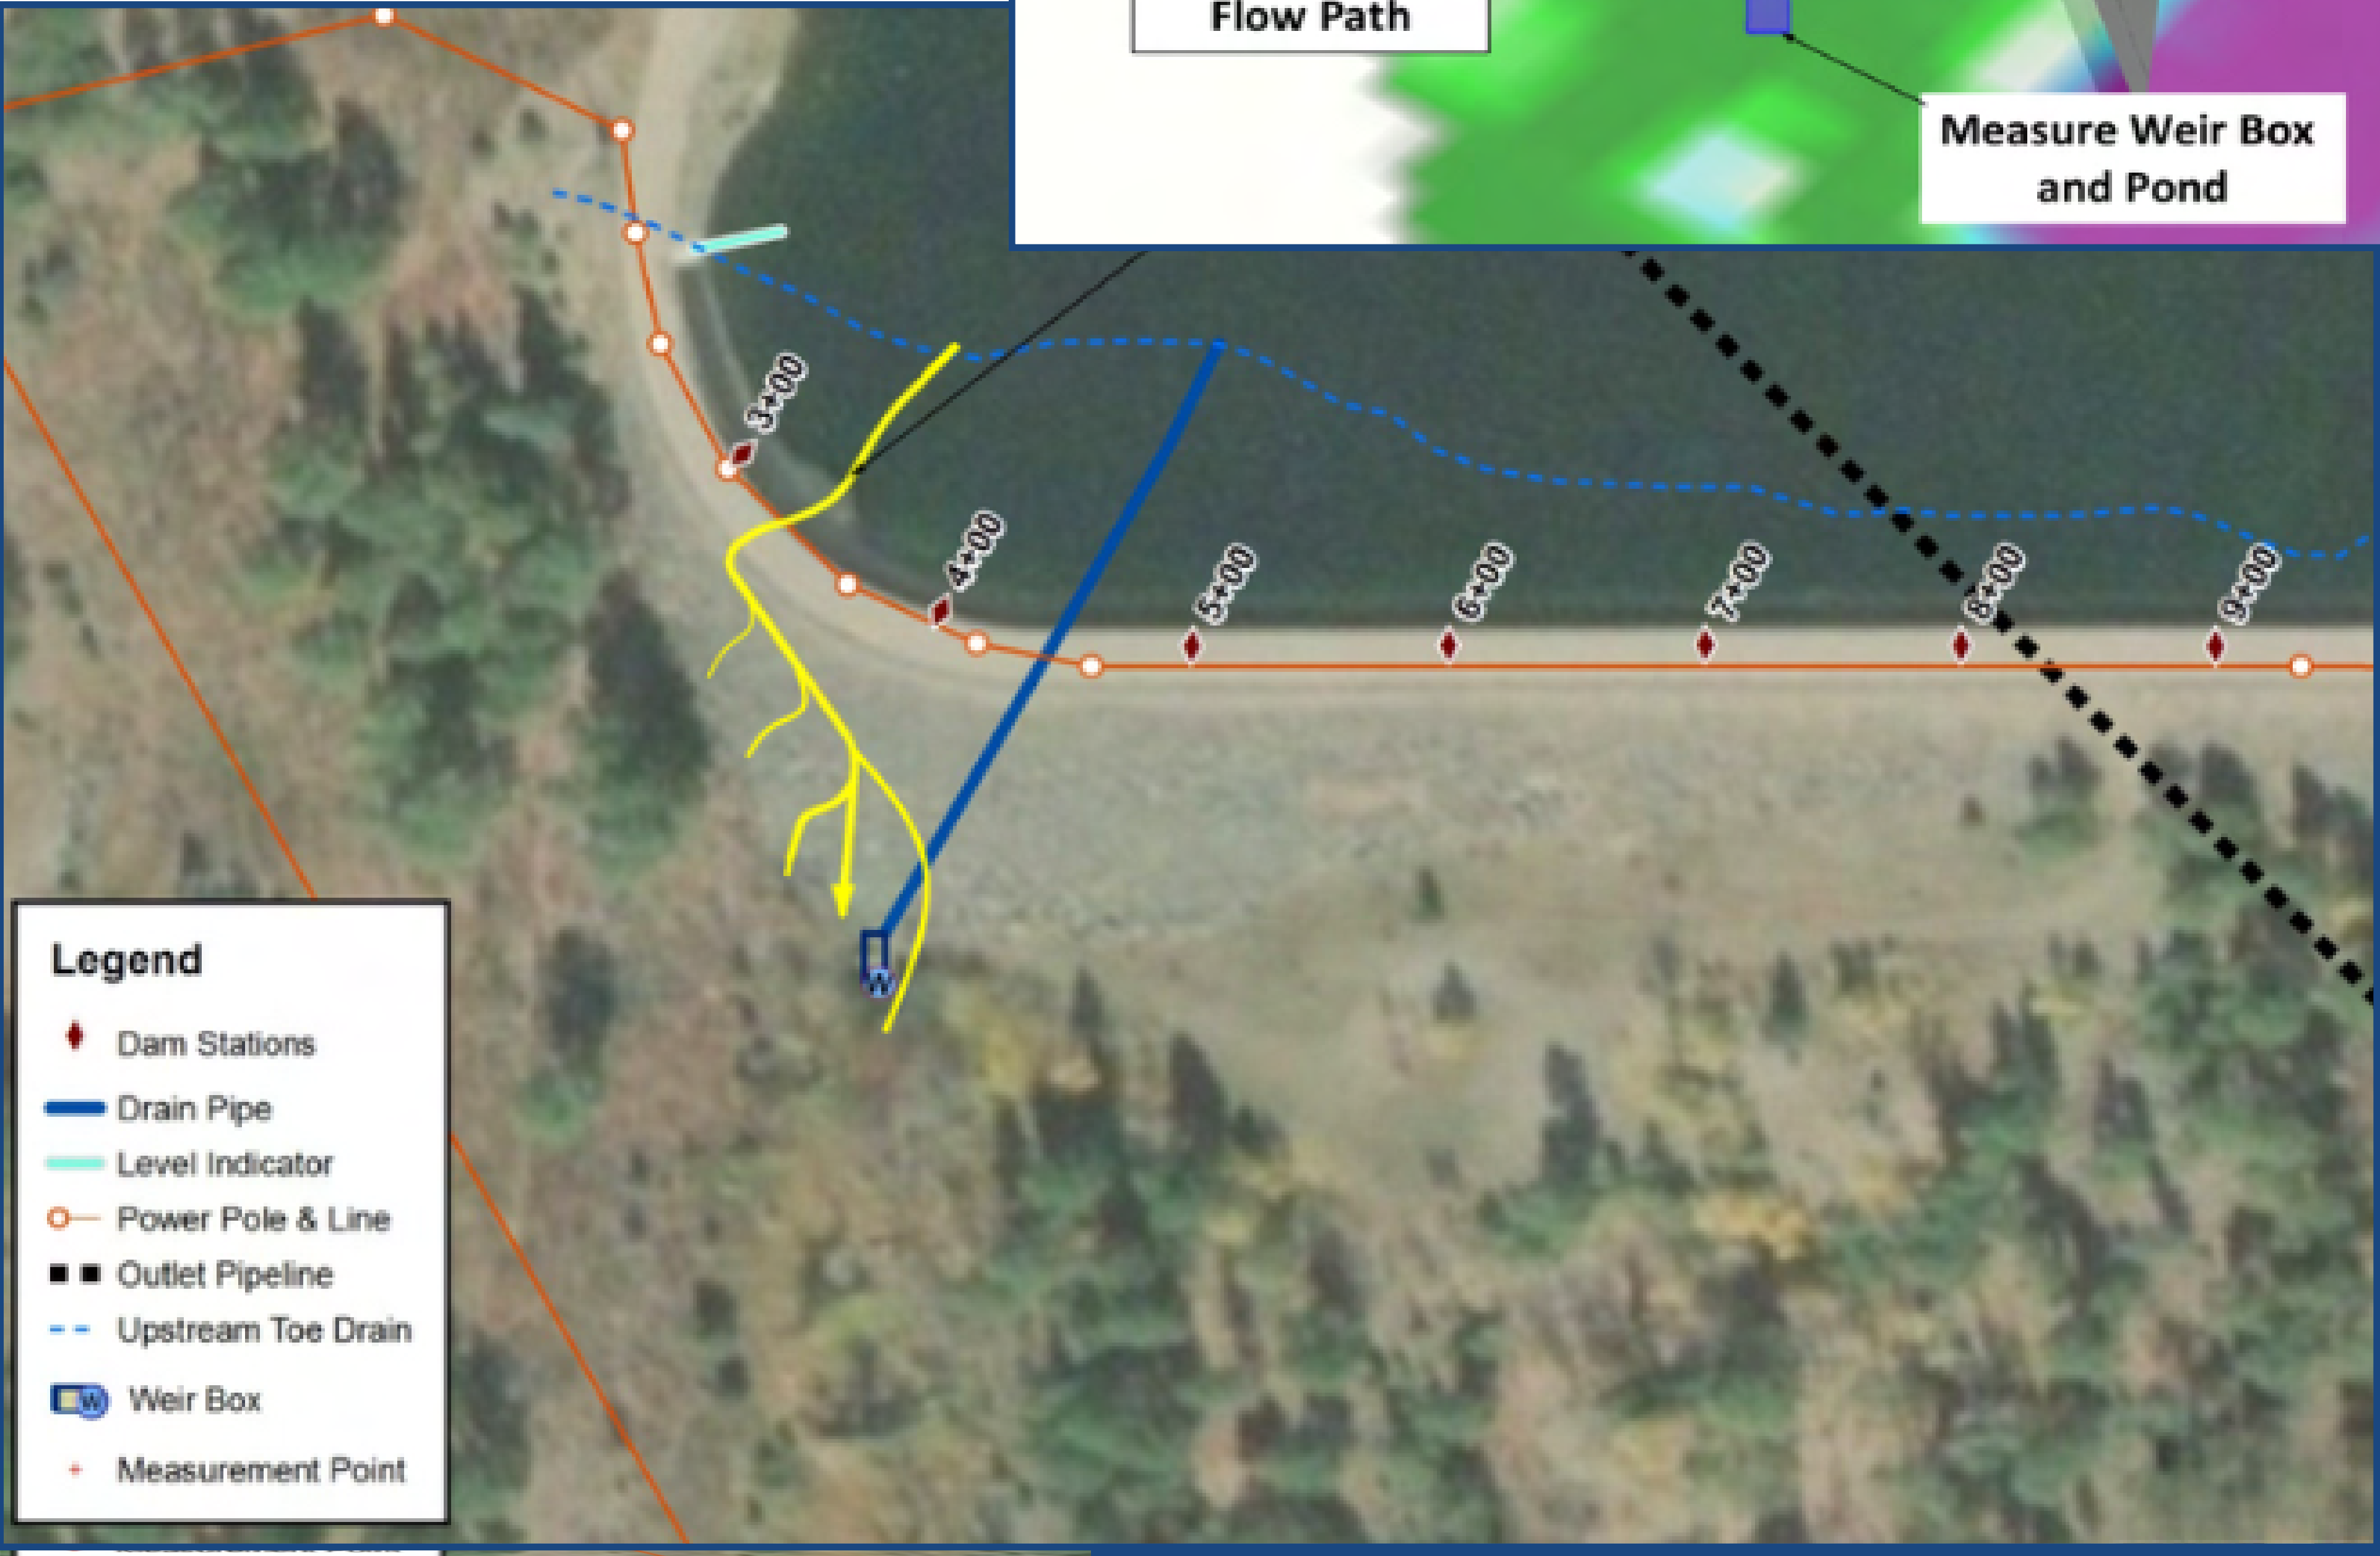
Conclusion Showing 2D And 3D Maps Of The Discovered Preferential Flow Path

The single defect causing a sudden increase in seepage flows in the right valley section of the dam was successfully pinpointed through a combination of diving, dye testing, and Willowstick geophysical exploration, proving highly effective in locating the hole. General findings from the comprehensive investigation of the upstream liner and foundation substantiated that the two discovered defects were similar and localized, likely stemming from construction-related issues. Despite being over 40 years old, the asphalt liner was found to be in good condition, with no other defects detected. The hole repairs were successfully implemented, utilizing state-of-the-art methods and a specialized contractor for asphalt liner construction and repairs. As the reservoir slowly returns to its maximum operating level, seepage flows in the right valley section have returned to their original ranges prior to the 2018 spike.
