# CASE STUDY: Understanding The Cause Of Seepage - Rust De Winter Dam

## USING TECHNOLOGY TO IDENTIFY DIFFICULT TO LOCATE SEEPAGE OUT OF A DAM

Willowstick LLC

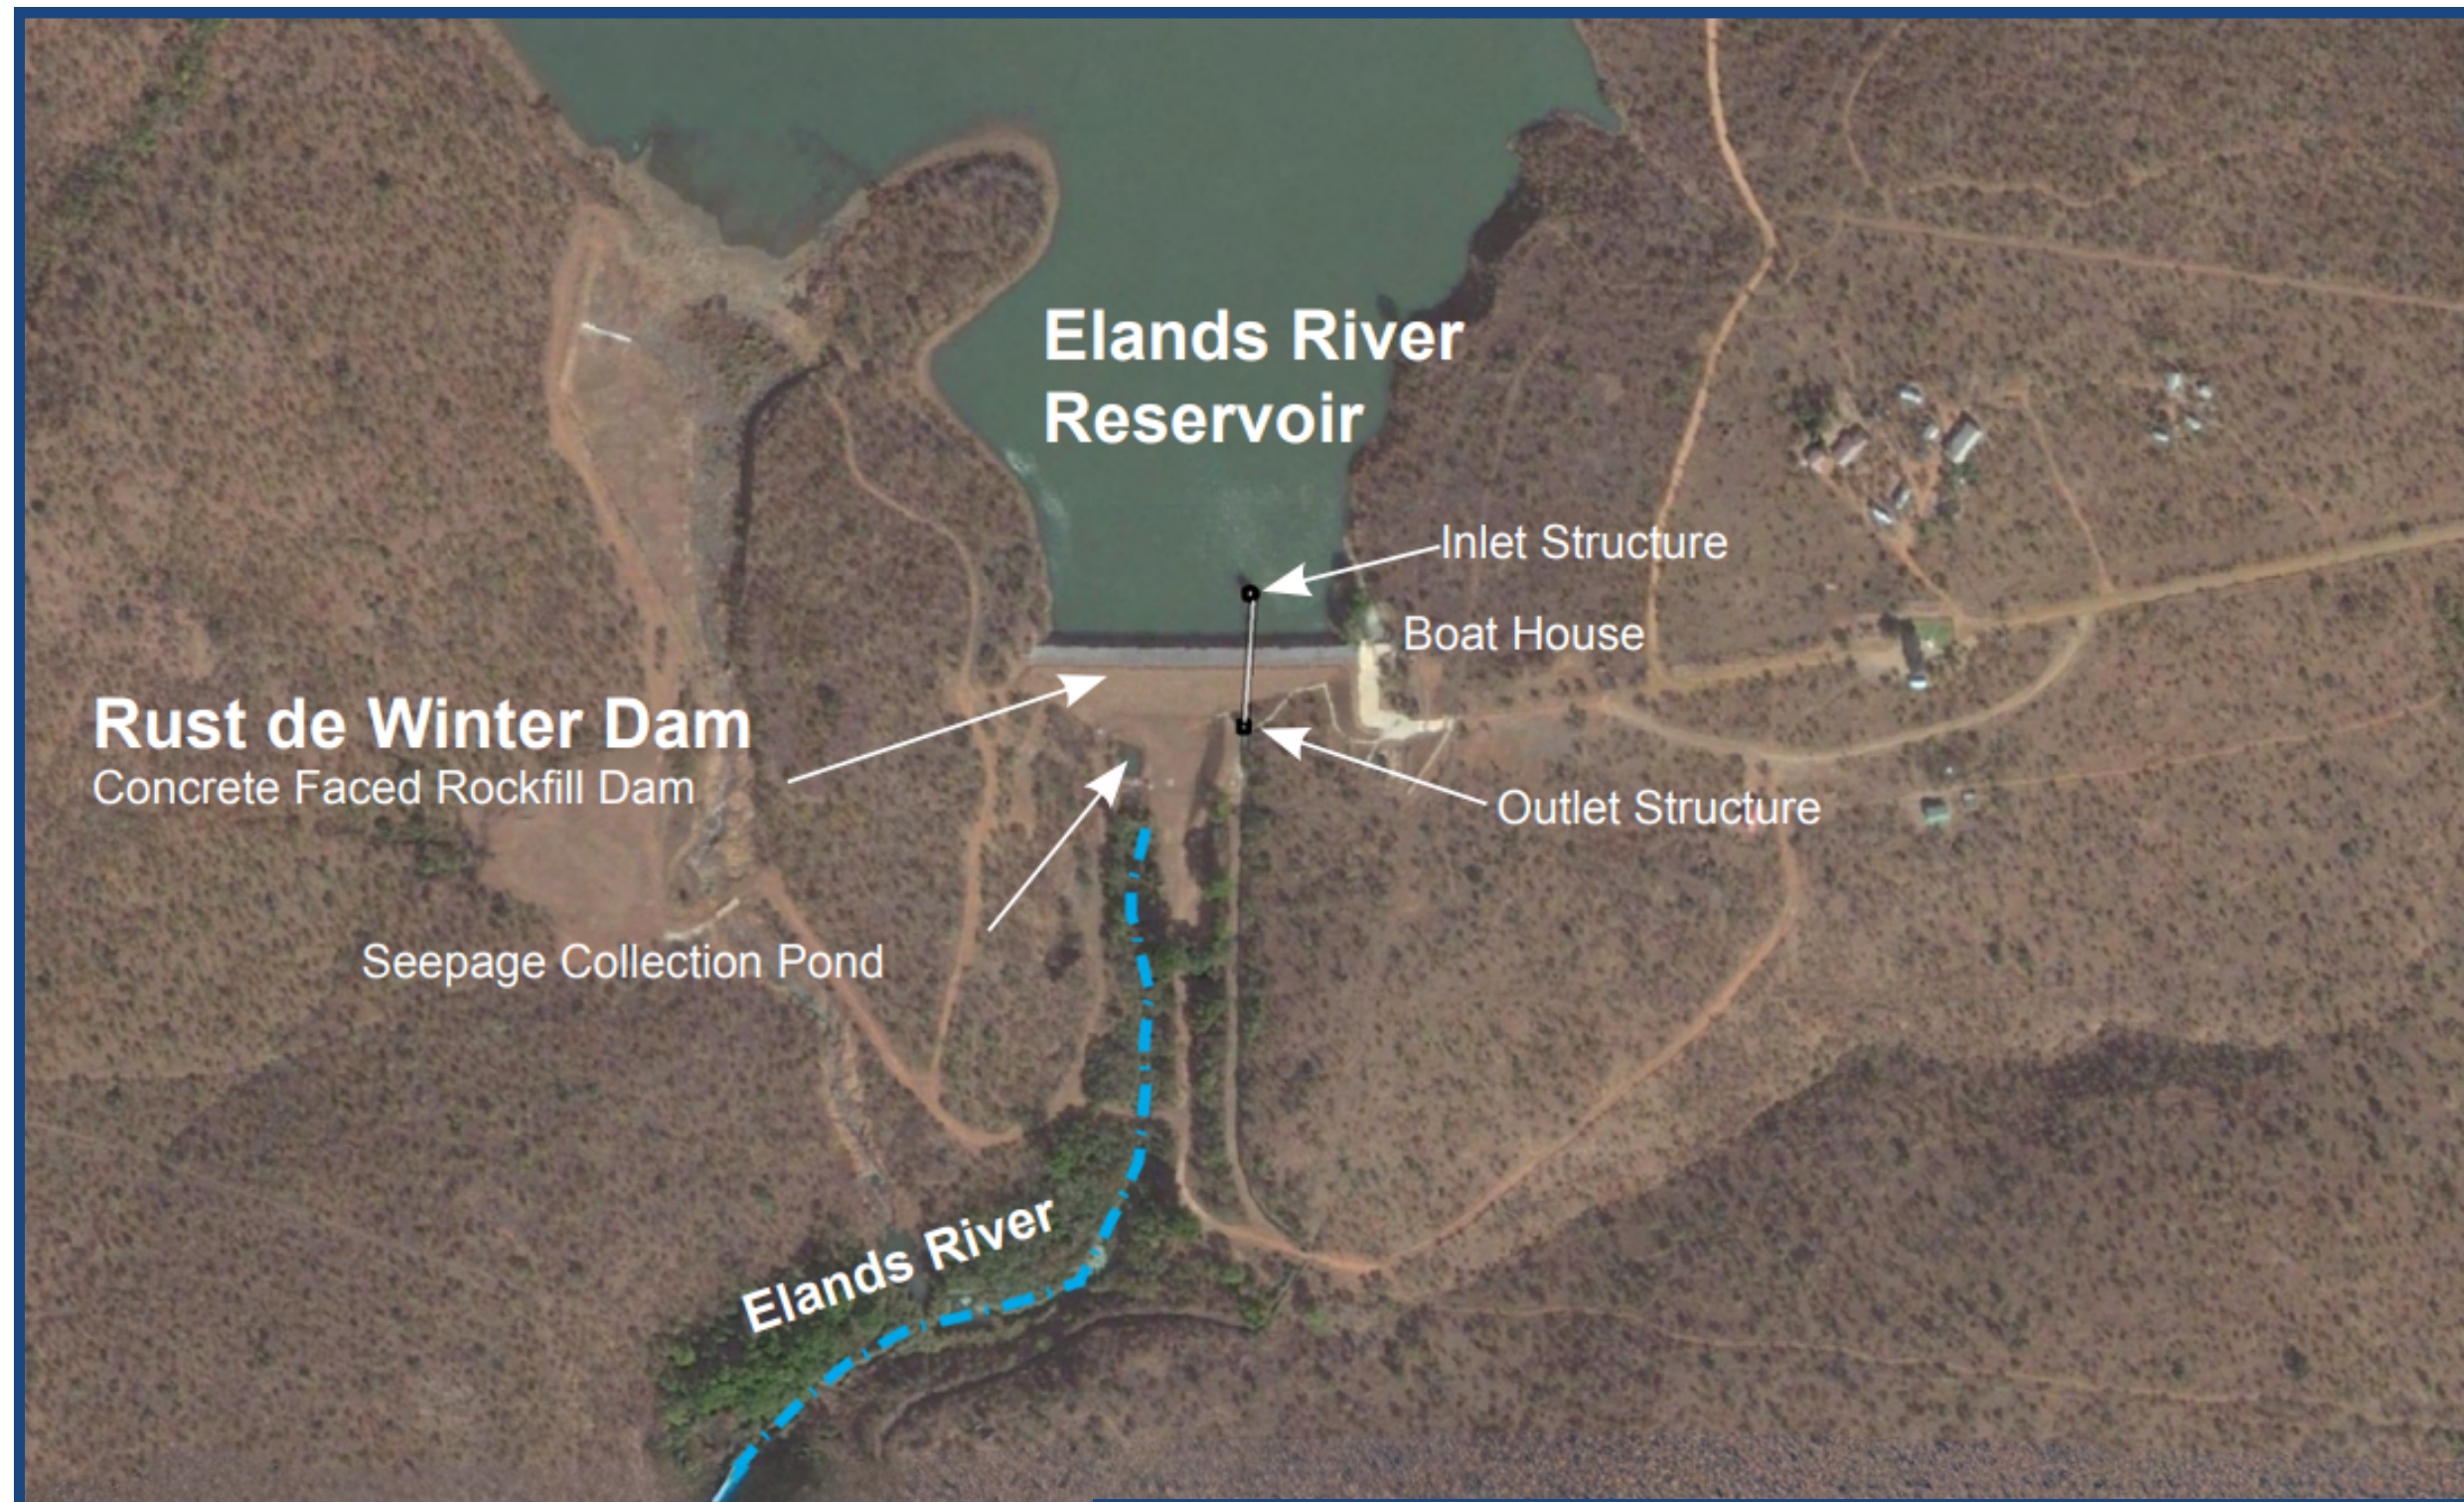
Seepage appeared along the downstream abutment and the cause was unknown

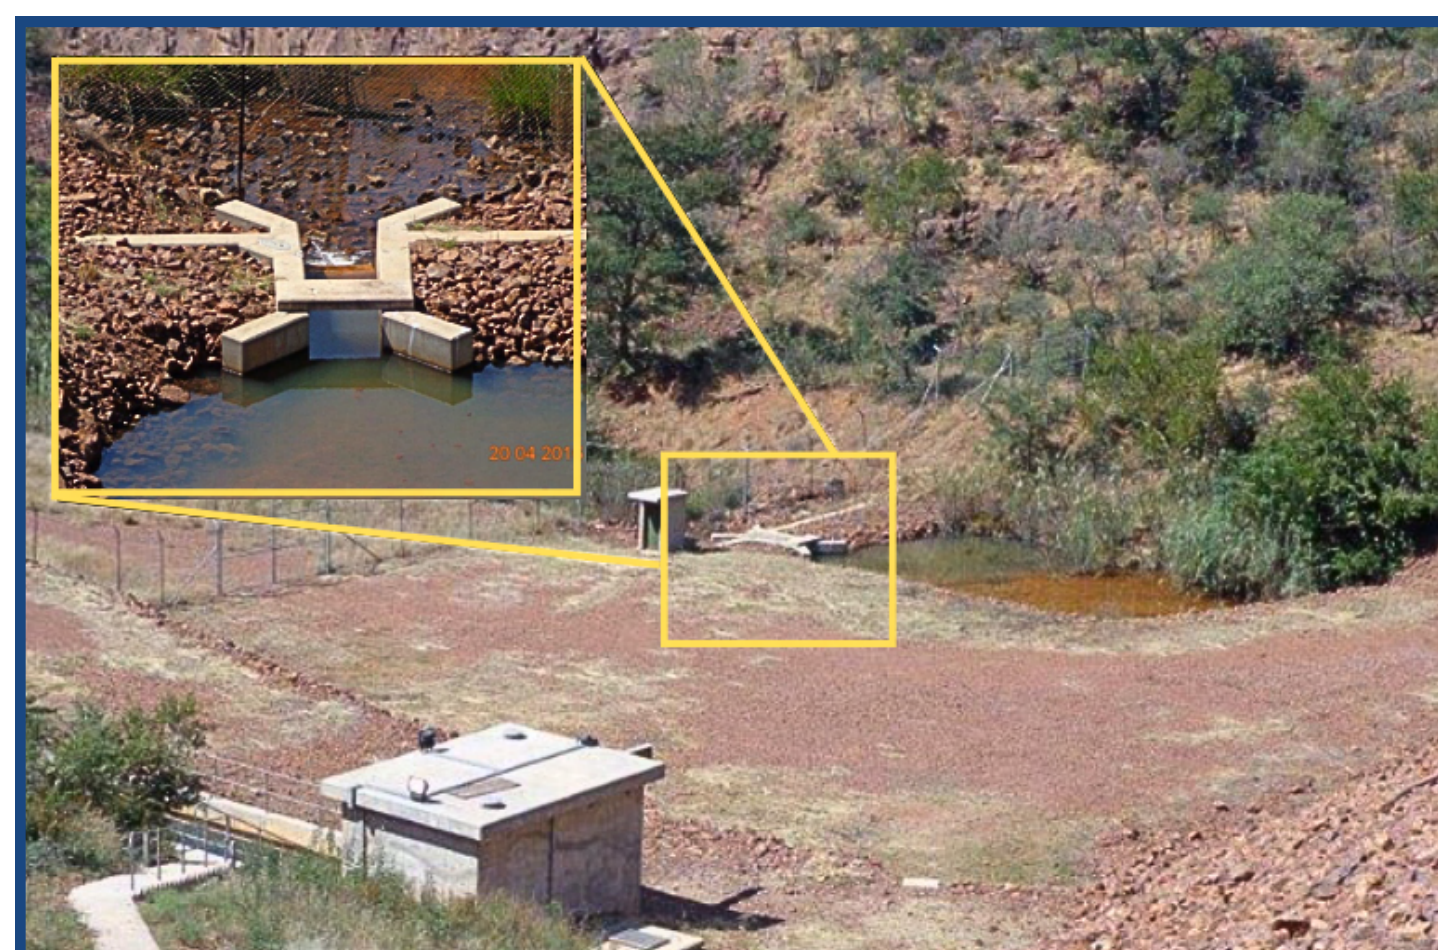
Seepage collection pond and weir designed to capture and monitor seepage from the dam

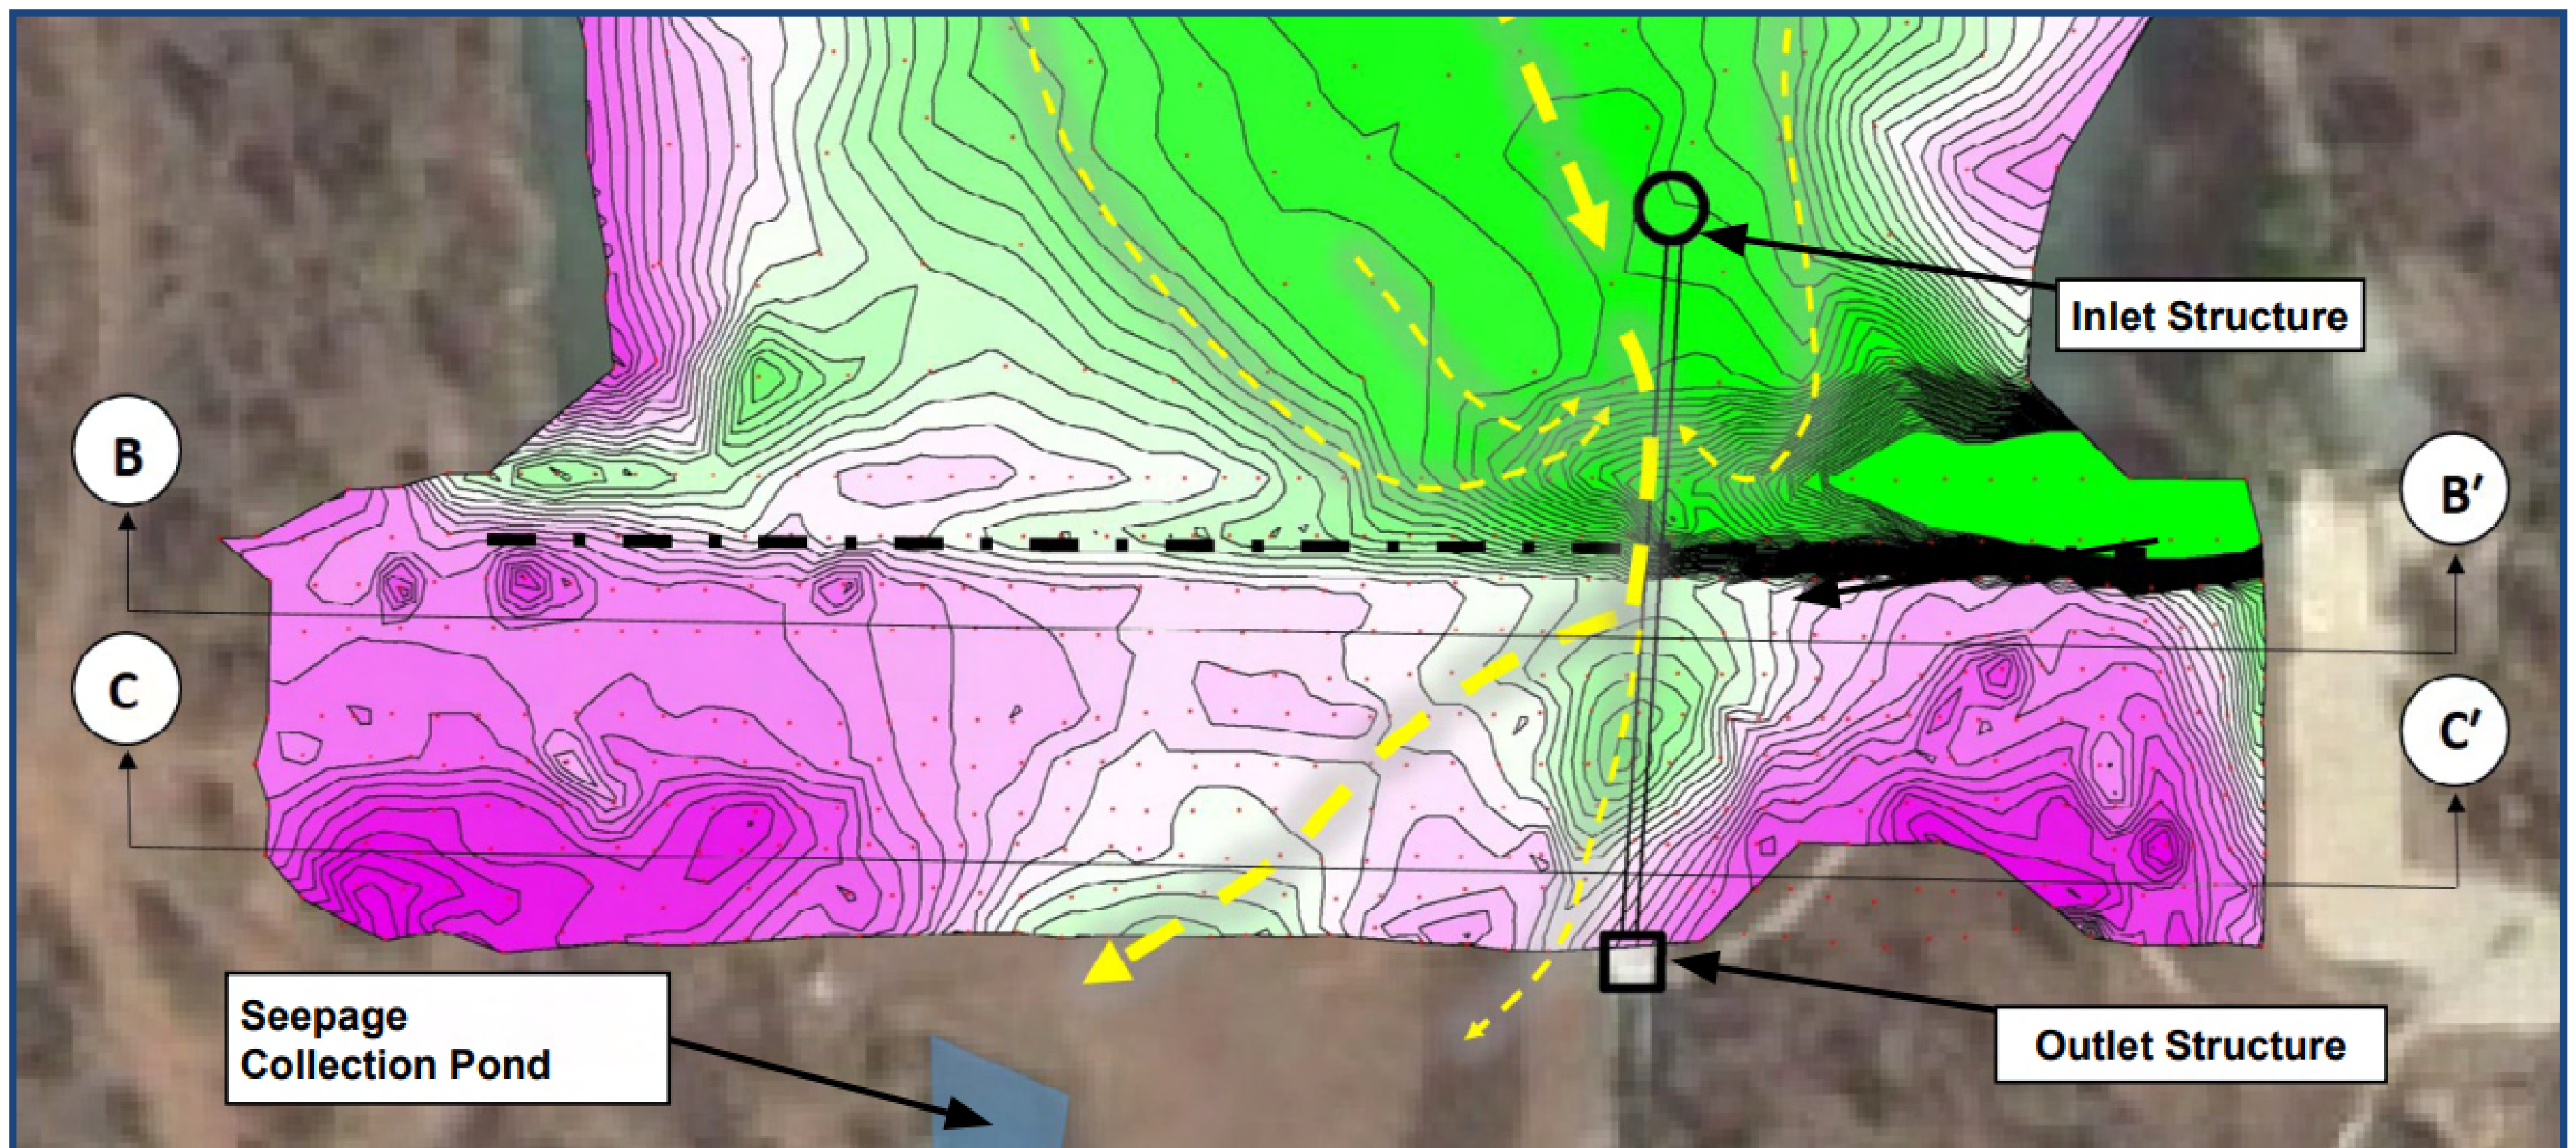
Ratio Response Map, the yellow lines represent preferential seepage flow paths

After the investigation the owner had a clear understanding of the leakage through the dam. In fact it proved conclusively that there were no leaks through the upstream membrane or indeed through the right abutment as assumed. The leak was found to be under the membrane and its cutoff, then under the pipeline where blasting may well have shattered the rock, and then it swung sharply from the left hand side of the dam towards the right abutment where the leak manifested itself as a flow on the surface.
