## Extraordinary Solutions Featured at Saluda Dam

## River Reservoir Dam

# Mapping Seepage through Earthen Embankments

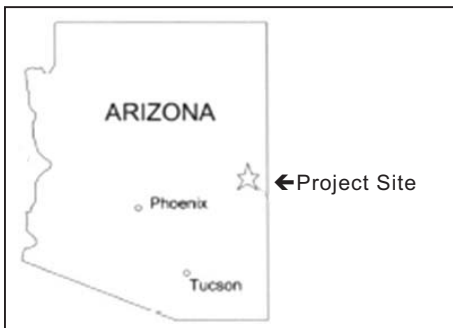
River Reservoir Dam is an arched earthen structure on the headwaters of the Little Colorado River. It is located about 15 miles southwest of Eagar, Arizona, and is owned and operated by Round Valley Water Users Association (RVWUA). In 1896 and based on very limited engineering, settlers constructed the dam using local materials and without a clay core. Due to recurring sloughing problems, the dam received significant modifications on at least four separate occasions.

The embankment consists of clayey soils within a rock-fill shell, measuring 1,100 feet long, with a maximum height of approximately 70 feet and is founded upon basalt bedrock.

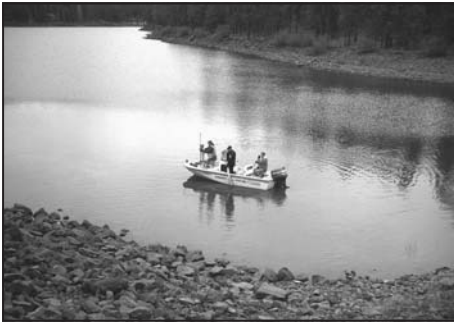
Taking readings from boat.

The equipment used to measure the magnetic field includes three sensors oriented in orthogonal directions, a data logger used to collect, filter and process the sensor data, a Global Positioning System to locate and map the field measurements, and a Windows-based handheld computer to store the GPS and magnetic field data. This equipment is mounted on a surveyor's pole and can be hand-carried to each measuring station.

The instrument measures the voltage from each of the three sensors located at each measurement station. The measured values correspond to the strength of the magnetic field. For quality control, a base station is established within the survey area. The field strength at the base station is measured at the beginning, middle and end of each field day. This data is used to identify any changes in the background magnetic field, such as diurnal drift. The magnetic field measurements collected during the survey of the larger region of interest are later normalized to compensate for these effects. The quality of the data is also assured by examining the signal-to-noise ratio in real time, and fluctuations in the data due to natural and man-made phenomena are removed. The horizontal and vertical magnetic field magnitudes and directions can be measured to further define the groundwater or seepage system. The survey data is later normalized to show relative highs and lows in the magnetic field strength.

For the River Reservoir Dam investigation, one electrode was installed in the lake, approximately 800 feet south of the western abutment, and a second was placed in the left abutment weir box, where the high silt content was observed (about 140 feet downstream of the dam crest). These two electrodes were connected by heavy gauge wire and linked to a 400Hz power generator. An electrical current was then induced between the two electrodes. A total of 107 magnetic measurements were taken on the upstream and downstream sides of the dam, as well as on the crest. Twenty additional measurements were taken from a boat in the reservoir. Upon completion of the fieldwork, the collected data was then sent back to the lab for interpretation. The measured magnetic field data were processed, contoured and correlated to other hydrogeologic information. This resulted in an enhanced definition of the extent and preferential flow paths of the seepage. The results of the survey pinpointed the area with the greatest leakage in both the horizontal and the vertical directions. Using this data, maps of the preferential flow paths that existed between the reservoir and the left abutment weir box and its associated drainage system were produced. This information was integral to the comprehensive remedy developed by the geotechnical engineers at TCB. Willowstick personnel mobilized rapidly on short notice and performed
